# SAFETY INVESTIGATION OF BOATING ACCIDENT

BOAT 710C  
TRIADELPHIA LAKE

JULY 18, 2012

Captain Jerry A. Warren

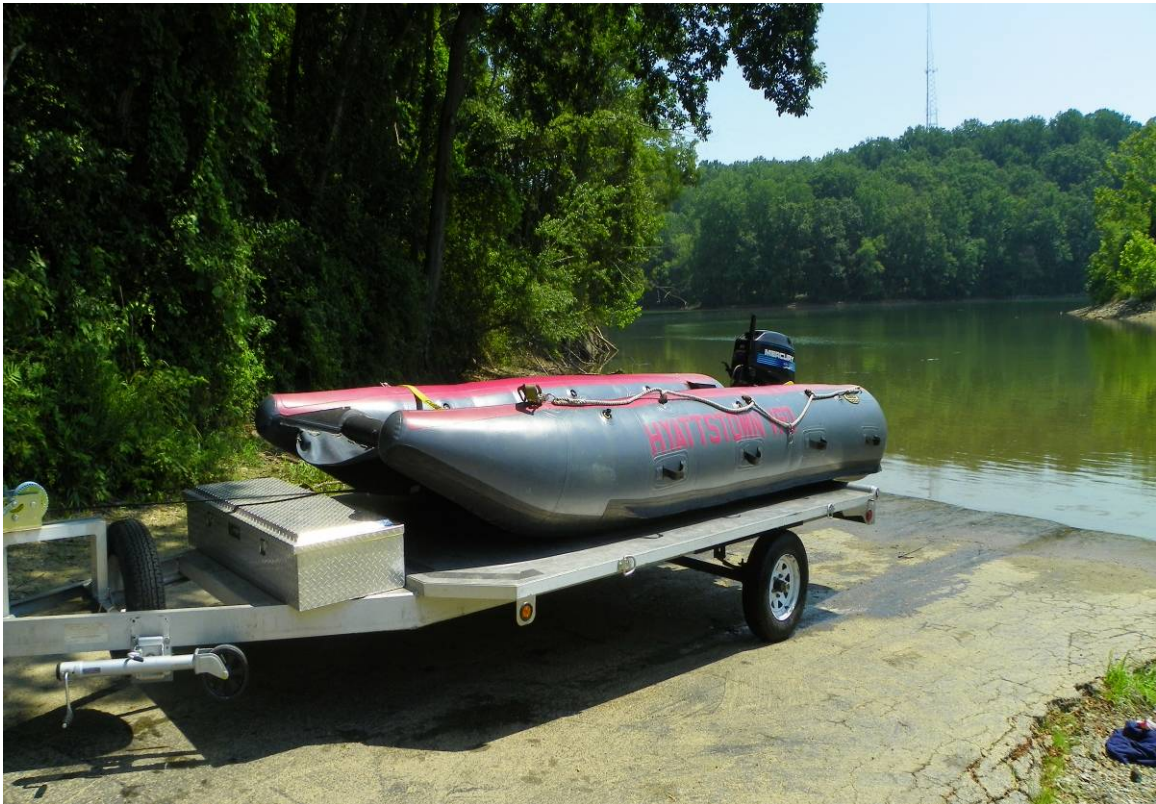
On Wednesday July 18, 2012 during a practical training session of Montgomery County's "Still Water Boat Operation" class at Triadelphia Lake, Boat 710C (rescue sled) flipped over with three personnel on board. The event was not part of the training exercise, and resulted in a personal injury and \$7117.63 in property loss.

Based on inspection of the boat and motor, mechanical factors for the over-turning of the boat were ruled out. It is determined that several human factors contributed to Boat 710C over-turning.
